# Home Inspection Report

1300 St Mary Street unit 207, Raleigh , NC 27605

Monday July 23, 2018

90012

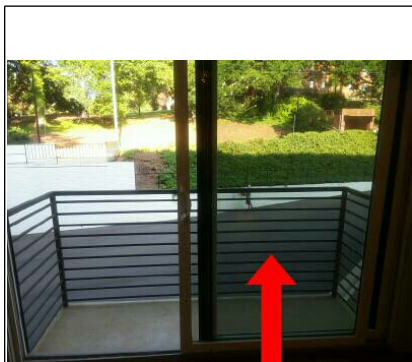
Comments Concert pad.  
Appears to be to be satisfactory.  
Patio door screen will continue to come off track. Recommend repair or replace.  
Metal grade to hold cement well paint and sealed from the weather.

Patio door and balcony.

1) Patio door screen does not stay on track. Recommend repair or replace roller. The screen will help keep insects out of the living area.

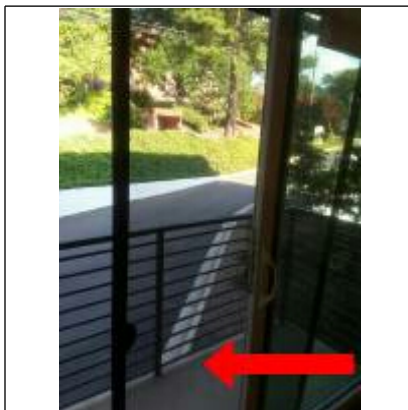
Continues to come off track.

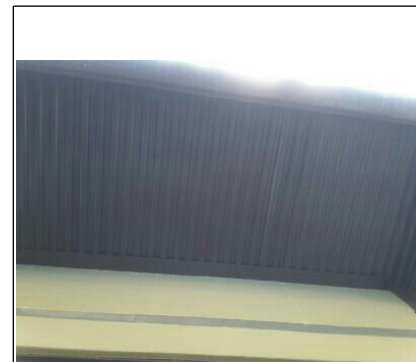
Metal grade under balcony.

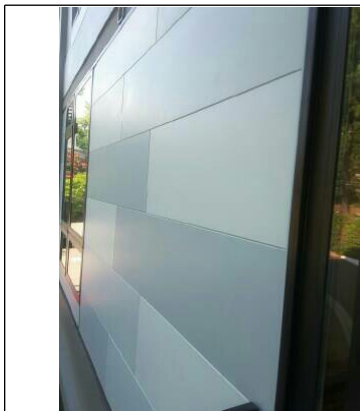
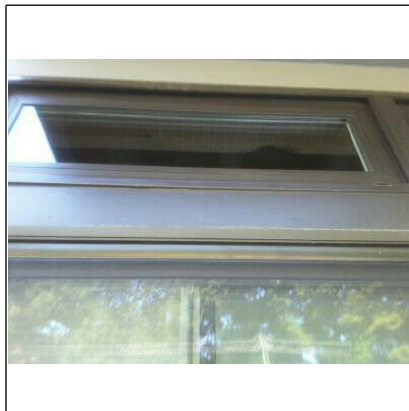
**Comments** Stone tile with metal flashing over patio doors. Along with extension fiber cement siding. Appears to be satisfactory.

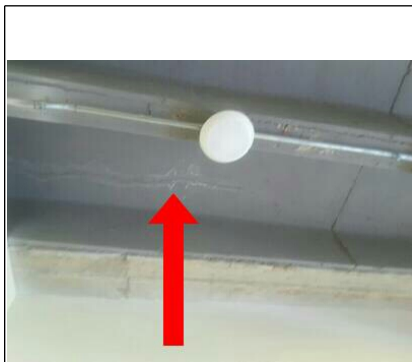
**Comments** Slab not visible due to flooring materials (carpet, hardwood, tile, etc.) not evaluated. Typical hairline cracks in slab. In ceiling living and master bedroom.

Settling crack.  
Also possible leak due to the efflorescence on the surfaces.

1) Efflorescence on the surface of the concrete. Efflorescence is caused by vapor migration through the slab bringing salts to the surface of the concrete. Recommend licensed professional to evaluate this area. Also recommend the buyer and agent to speak with the property manager to see if they were aware of this situation.

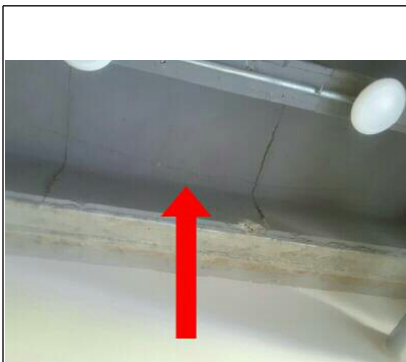
Settling crack.

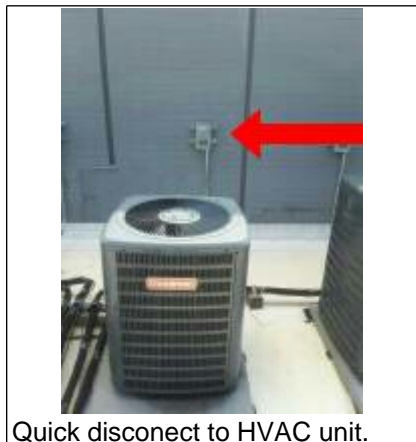
Quick disconnect to HVAC unit.

**Comments** Recommend licensed HVAC to evaluate system and service check. HVAC systems need to be serviced twice a year once in the winter and summer. This will allow the system to function properly. Heating and cooling system appears to be satisfactory. Note check with your property management and see if they have or will have this system done. Also recommend the return air supply be clean of the dust by the air filter.

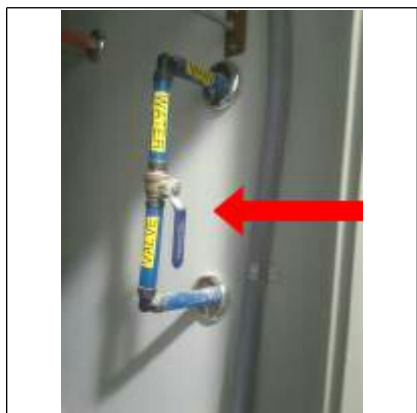
**Comments** Main shut off at street. And in side closet beside front entry door.  
Also note pvc swer gas pipeline vent to roof top.  
Also dry vent galvanized type vent along master room ceiling you exterior.

Main shut off for unit.

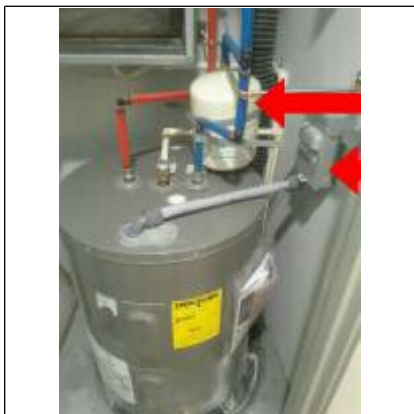
Water pressure system.  
Quick disconnect to water heater.

Comments Recommend cleaning out water pan.

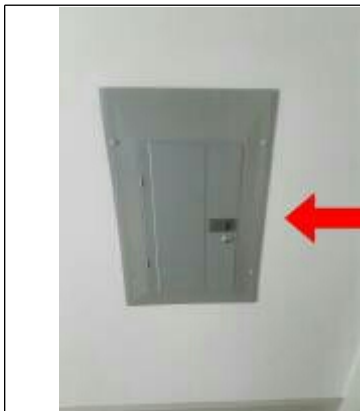
Subject panel appears to be satisfactory behide master bedroom door.

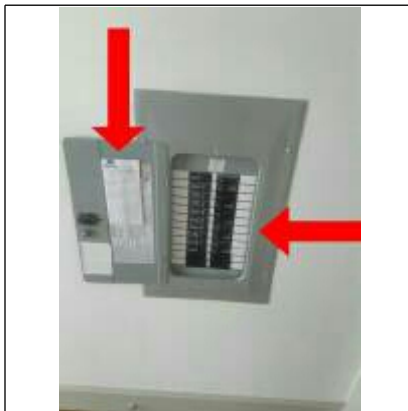
Appears to be satisfactory the Sud panel box liableing.

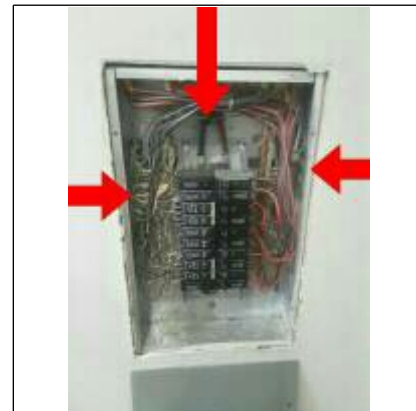
All neutral and ground are isolated on the bus bar.

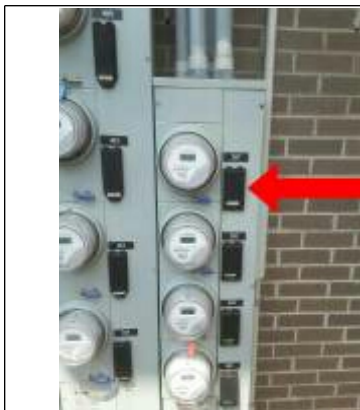
Quick disconect to meter box.
